US-191, Colorado River Bridge Study

Prepared for the
Utah Department of Transportation
UDOT Project No. BRF-0191(23)128

HDR Engineering, Inc.

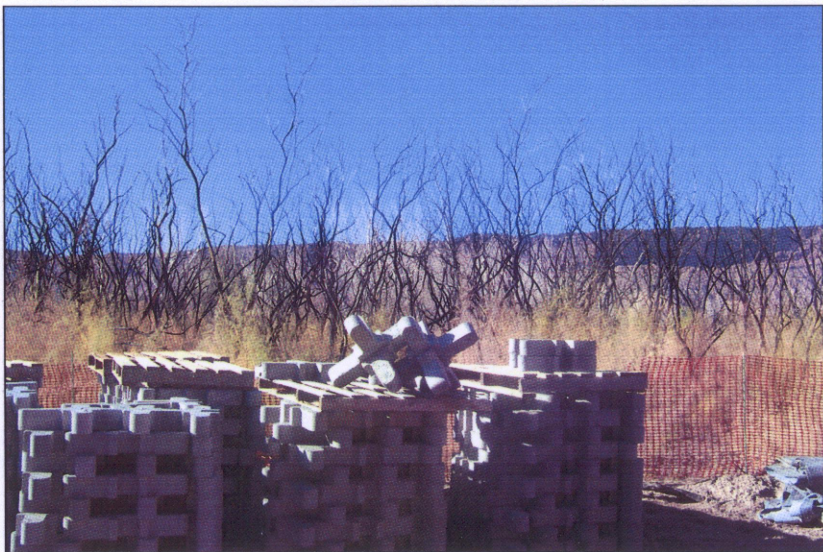
Figure 1. A-Jacks

The scour countermeasures used at the Colorado River Bridge consisted of fiber wrap around the piers and bents, and placement of A-Jacks armor units at three scour-susceptible areas of the bridge (piers 5, 6, and 7). See Figure 1. The single A-Jacks structures were banded together to form modules and were then placed in a matrix on the streambed. Figure 2 shows the design for the A-Jacks deployment. This design is unique, and there have not been many (if any) long-term case studies for this type of deployment into steep, mobile gravel bed river environments. Figure 3 and Figure 4 show the installation of the fiber wrap.

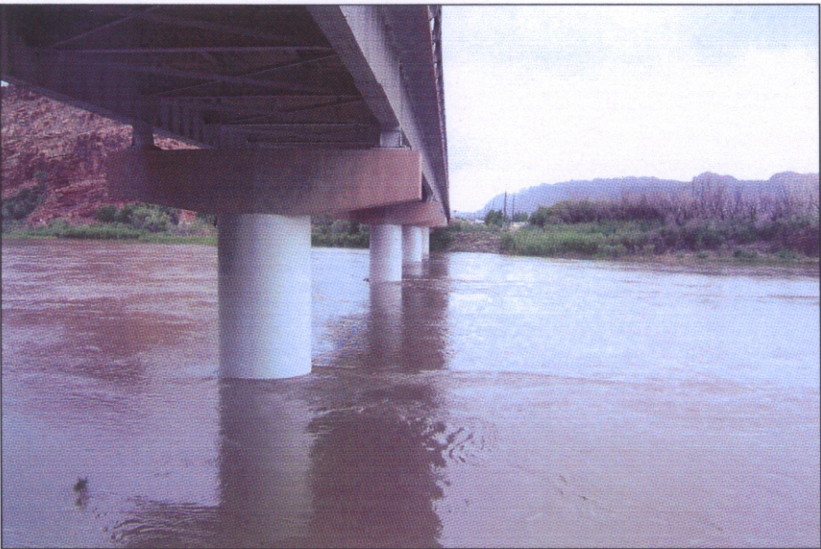
Figure 5. Water Level on a Subsequent Site Visit, May 11, 2004 (Looking South)

Figure 5 shows the water level on a site visit.
